PACIFIC EARTHQUAKE ENGINEERING RESEARCH CENTER

August 17, 1999, Kocaeli, Turkey Earthquake Field Investigation Report

**A report to the PEER Program of
Applied Earthquake Engineering Research on
Lifeline Systems**

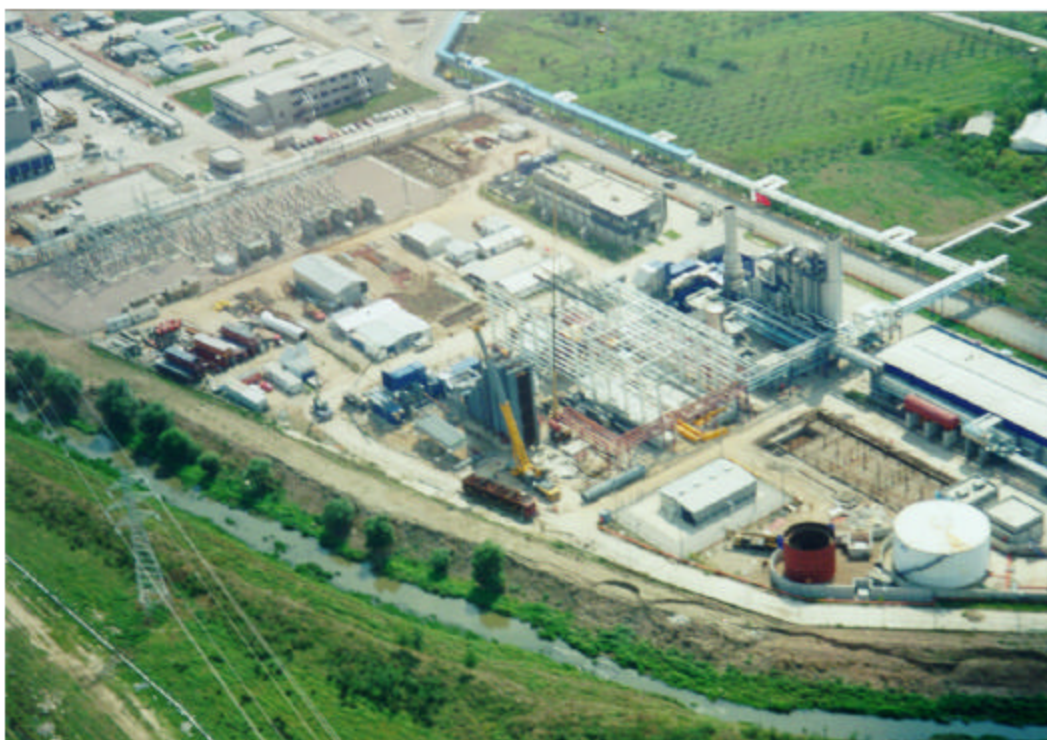
Enerji SA Autoproducer (Cogeneration) Plant, Kosekoy, Kocaeli Province. A 40 MW natural gas fired cogeneration plant, the Enerji SA plant (see figure 2), is part of an industrial park several kilometers west of the Kosekoy substation southeast of Izmit and within about three kilometers of the fault rupture. The estimated peak horizontal ground acceleration at the site was 0.4 g. The plant consists of a frame 6 combustion turbine generator (CTG) and Heat Recovery Steam Generation (HRSG) unit and was put into service in March 1998. Two additional units were under construction at the time of the earthquake. The CTG was built on piles due to the soft soil conditions, but the HRSG was not, even though both units were built on semiconsolidated alluvium.

At the time of the earthquake, the CTG's lubrication oil high/low alarm signaled, and the plant tripped. The emergency diesel generator started in two minutes. The turbine was cooled down, turning slowly for two days. The immediate post-earthquake inspection revealed only minor damage: the CTG foundation settled differentially by 0.5 cm; nuts on the foundation connection bolts partially loosened; nuts on the anchorage for the water treatment plant also loosened; the HRSG displaced sufficiently to pull a base plate off its threaded anchors; there was some concrete spalling on the west side of the HRSG foundation; and unanchored parts storage shelves and other inadequately restrained objects were damaged. This amount of differential settlement is within the preliminary design tolerance for some modern US built natural gas-fired

There was some damage to the two units under construction, including twisted I-beams, the input flue colliding with other parts in the HRSG, and an 80-tonne package boiler jumping off its foundation because it was not yet attached. The plant manager said that the inlet flue of the partially built HRSG had been damaged by colliding with other parts of the HRSG.

Figure 2. Oblique aerial photo of the Enerji SA cogeneration plant showing the housing for the frame 6 CTG and the HRSG.

The insurance carrier for Enerji SA asked for a detailed inspection before the plant could be restarted, which took about 3 1/2 weeks following the earthquake to reach the final testing stage. All the pressure switches had to be re-calibrated. This was an unforeseen delay and if there had been a customer available to receive power this could have been a significant financial loss to Enerji SA. During that period, the substation was repaired using spares on hand for the new construction, and was reconnected to the TEAS grid at 34.5 kV in 40 hours and at 154 kV in 60 hours. As the Enerji SA customers recovered their operations, they could be supplied by the grid until the plant restarted.

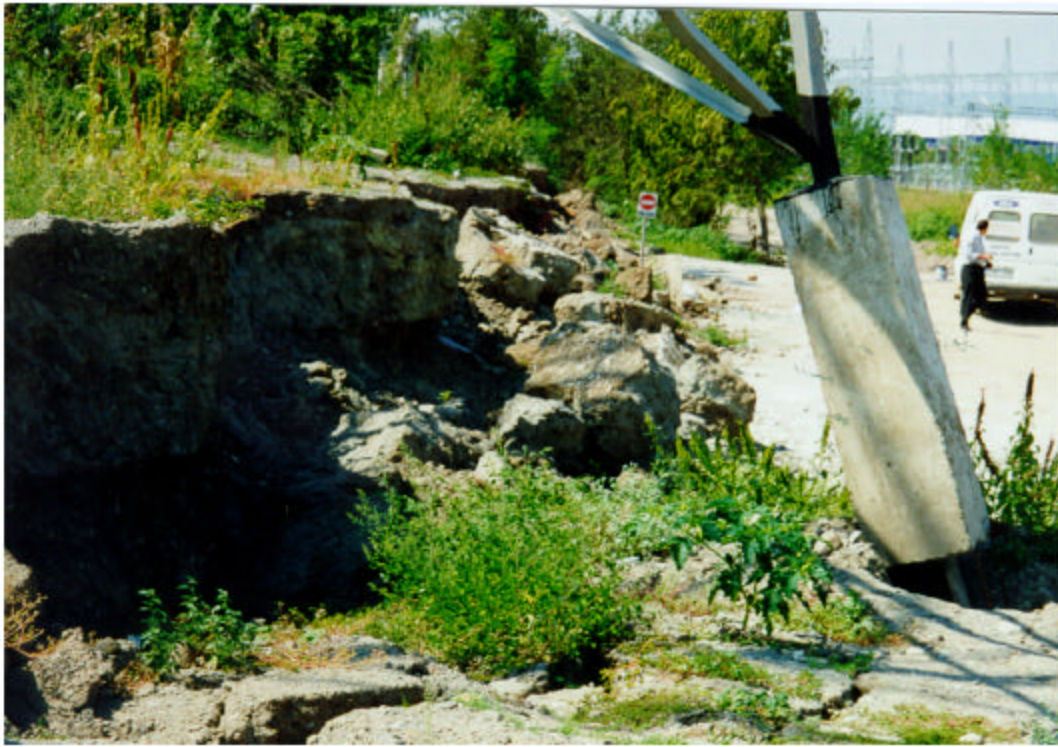
connection to a substation that is part of a large Ford automotive manufacturing facility under construction near the city of Golcuk (see figure 3). Surface strike-slip faulting with a large normal component crossed the foundation of the tower, and twisted and elevated one leg and its concrete footing about two meters out of the ground. The tower did not tilt. It was supported by the remaining three legs, and remained in service.

Figure 3. Photograph of the footing of a 154 kV electric transmission line tower displaced by surface rupture along the North Anatolian fault near Golcuck, Turkey.
